JOURNAL OF HIGHWAY RESEARCH

AUGUST 1934

AN OIL-TREATED SURFACE IN WYOMING

A Study of Oil-Treated Roads in Colorado and	Wyo	min	g.	٠	٠	٠	٠	•	٠	٠	137
Power-Shovel Operation in Highway Grading											147

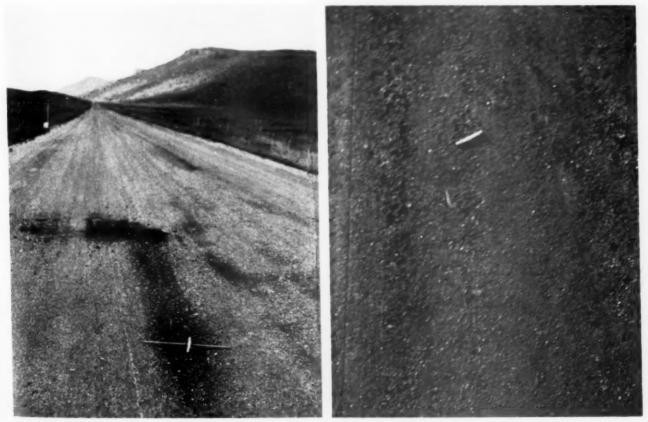
Typical Oil-Mix Surfaces Which Have Given Excellent Service. The Mix Shown on the Left Was Rich and Unstable the First Year and Was Remixed with Additional Gravel. It Was Three Years Old at the Time of Inspection. The One on the Right Had Received No Maintenance of Any Kind Since Its Construction Four Years Prior to the Inspection.
